# Manhole Inspection Summary

Manhole # S290\_\_047MH

Insp Date: **4/14/09 11:59 AM**

**Location** Address: **W WEST ST**

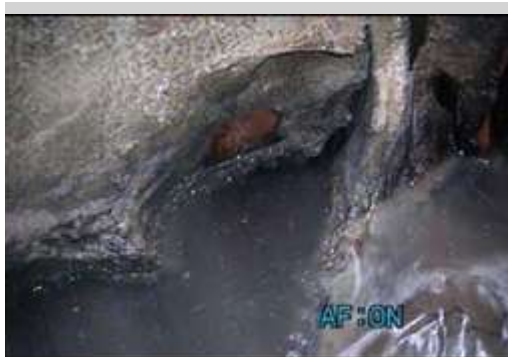
Miscellaneous

NO PIPE AT 5 OCLK  
Might have been active pipe connection at one time.

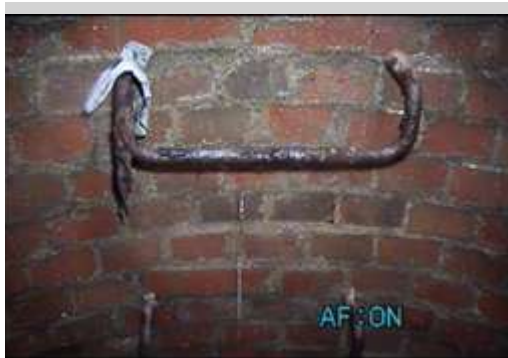
Defect 5

**Steps** Count: **7** Missing: **0** ☒ **Corroded**

**Surcharge** ☒ **Evidence Of Surcharge** Depth: **4** (ft.) ☐ Active Surcharge Present

CORRODED RUNG, SURCHARGE  
EVIDENCE

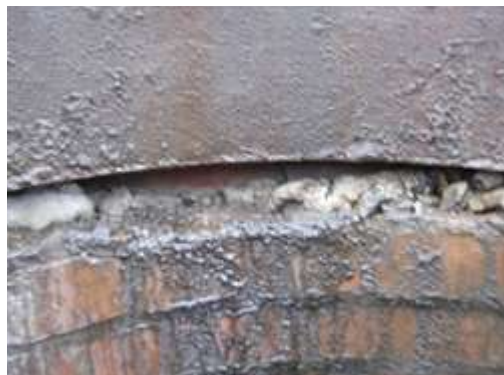
Defect 4

Condition: ☐ Sound ☐ Cracked ☐ Root Intrusion ☐ Loose Brick ☒ **Deteriorated**

Infiltration: ☐ None ☒ **Joint** ☐ Cracks ☒ **Mortar** ☐ Roots ☐ Wall

DETERIORATED CHIMNEY,  
INFILTRATION AT JOINT & MORTAR

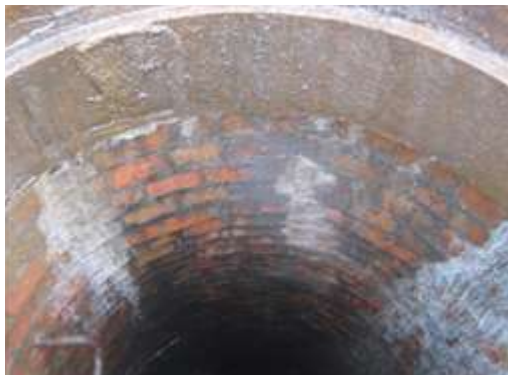
Defect 3

**Frame** Offset: **0** (in.) Condition: ☐ Sound ☐ Cracked ☒ **Leaks**

LID/FRAME INFILTRATION

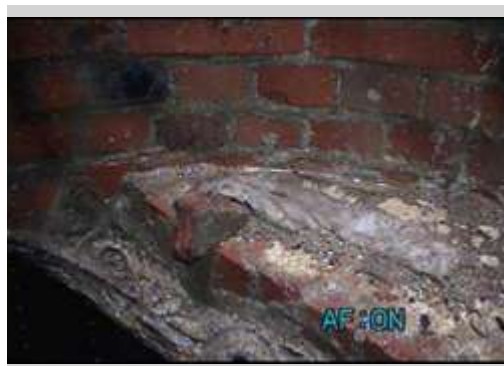
Defect 2

Condition: ☐ Sound ☐ Cracked ☐ Root Intrusion ☐ Deteriorated ☐ Leaks ☒ **Debris**

DEBRIS ON BENCH

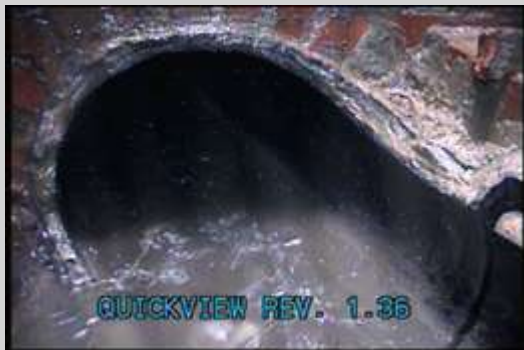
12 O'Clock Outflow

18 in. Circular Gravity Sewer  
Pipe Out @ 12 O'Clock

Pipe Height: **18** (in.) Rod and Bar (Angled)  
Pipe Material: **Clay** ☐ Pipe Lined  
Invert Depth: **13.42** (ft.) Flow Characteristics: **Fast**  
Deposits: ☒ None ☐ Mud ☐ Sludge ☐ Debris ☐ Grease  
Silt Depth: **0** (in.) Deposits Extent:  
Infiltration: **None** Pipe Seal Cond: **Sound**

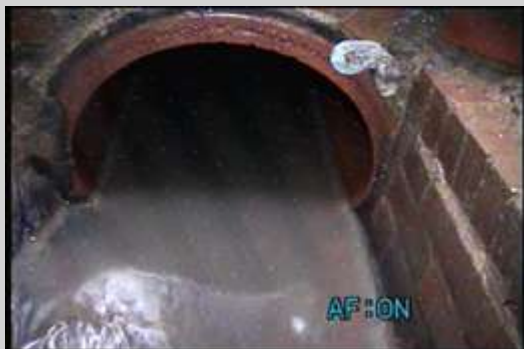
6 O'Clock Inflow

18 in. Circular Gravity Sewer  
Pipe In @ 6 O'Clock

Pipe Height: **18** (in.) Rod and Bar (Angled)  
Pipe Material: **Clay** ☐ Pipe Lined  
Invert Depth: **13.34** (ft.) Flow Characteristics: **Fast**  
Deposits: ☒ None ☐ Mud ☐ Sludge ☐ Debris ☐ Grease  
Silt Depth: **0** (in.) Deposits Extent:  
Infiltration: **None** Pipe Seal Cond: **Sound**
